Preliminary Frontage Technical Information Report

Issaquah High School #4 and Elementary School #17 4221 228th Ave Southeast Issaquah, WA 98029 2180412.10

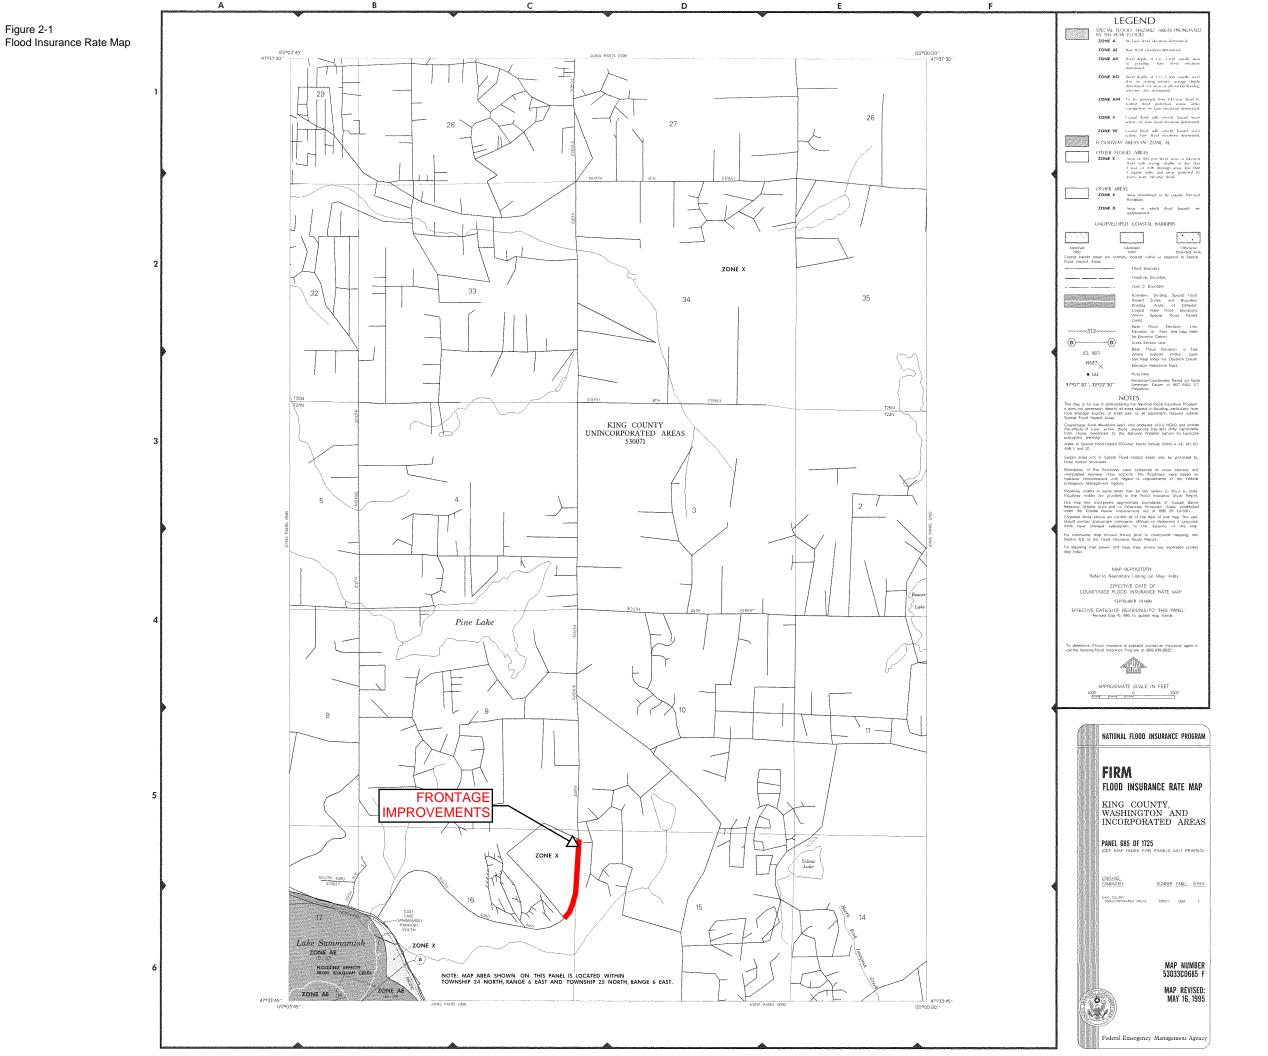
Figure 2-1

Figure 2-1.....Flood Insurance Rate Map

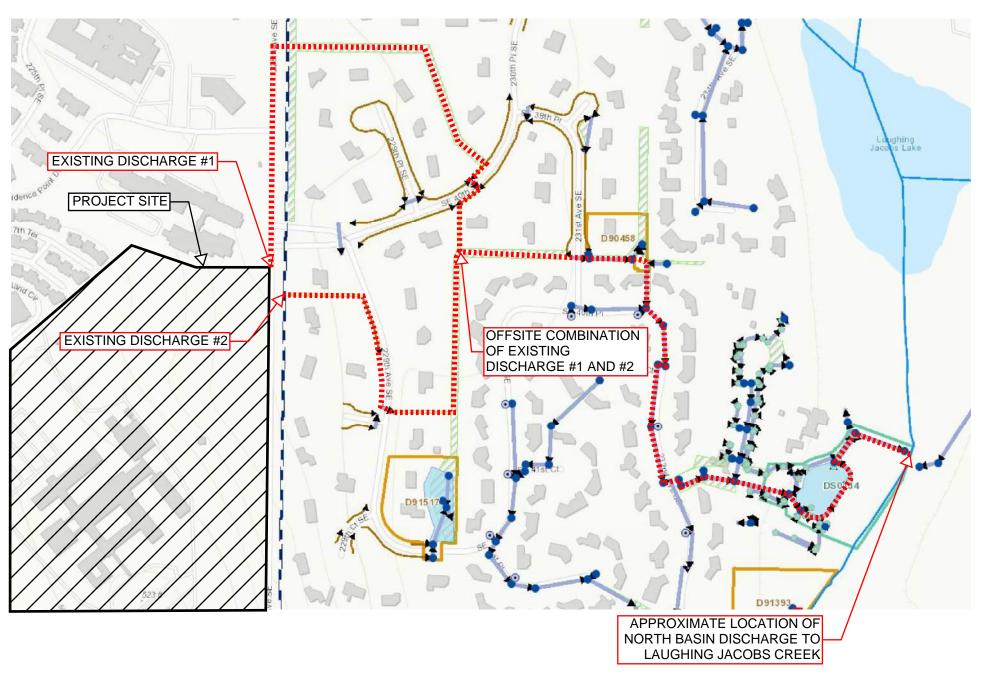
Page 1 of 3

OFF-SITE ANALYSIS DRAINAGE SYSTEM TABLE SURFACE WATER DESIGN MANUAL, CORE REQUIREMENT #2

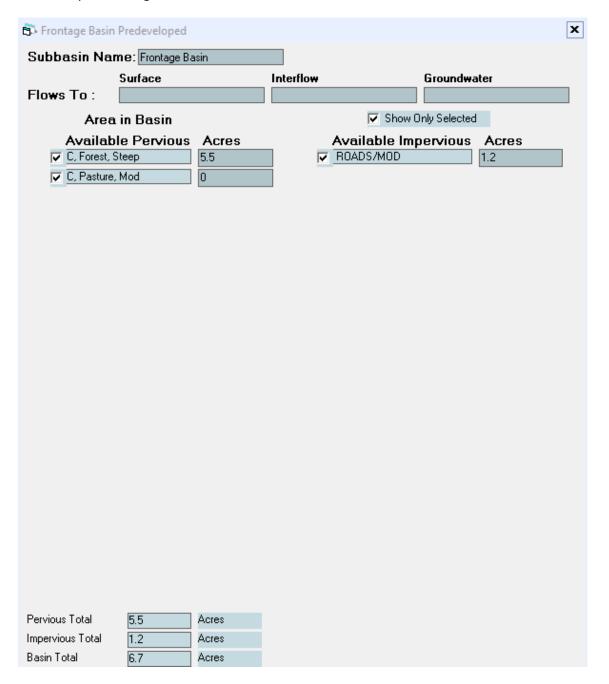
Predeveloped Frontage Basin

The 228th Avenue Southeast Frontage Basin, under existing conditions, is comprised of the existing 228th Avenue Southeast roadway and a portion of forested area on the west side of the project site. The existing 228th Avenue Southeast conveyance system is the existing downstream discharge location of the above mentioned onsite vegetated areas. 229th Avenue Southeast is an existing roadway with pollution generating asphalt pavement. This existing asphalt pavement is going to be protected, as shown on the civil plans, with only maintenance activities proposed on this pavement. This existing pavement is included in the WWHM flow control model as impervious roadway in the developed condition because it is neither new nor replaced surfacing but an existing hard surface.

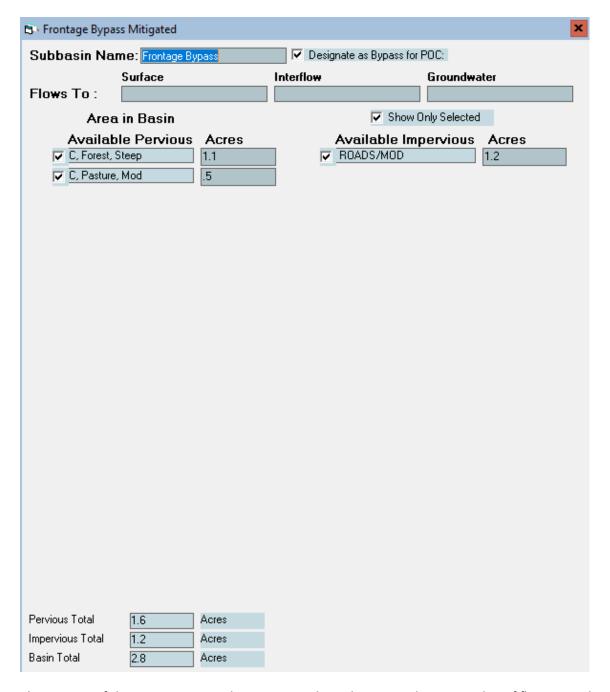
Frontage to Bypass

This portion of the Frontage Basin does not pass through proposed water quality of flow control facilities. The WWHM flow control model was set up to model this portion of the Frontage Basin as discharging directly to the POC without flow control being provided while the rest of the Frontage Basin, discussed below, discharges to the Detention 8 for flow control prior to discharging downstream. Refer to Figure 1-3 for existing and proposed basin maps.

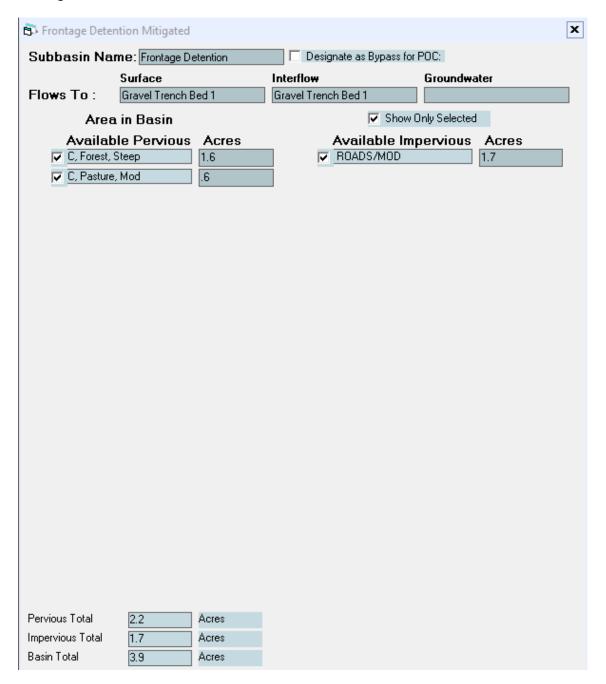
Frontage to Treatment and Detention

This portion of the Frontage Basin discharges through both water quality treatment as well as Detention 8 for flow control prior do discharging downstream. Refer to Figure 1-3 for existing and proposed basin maps. Refer to Figure 4-2 for WWHM water quality calculations.

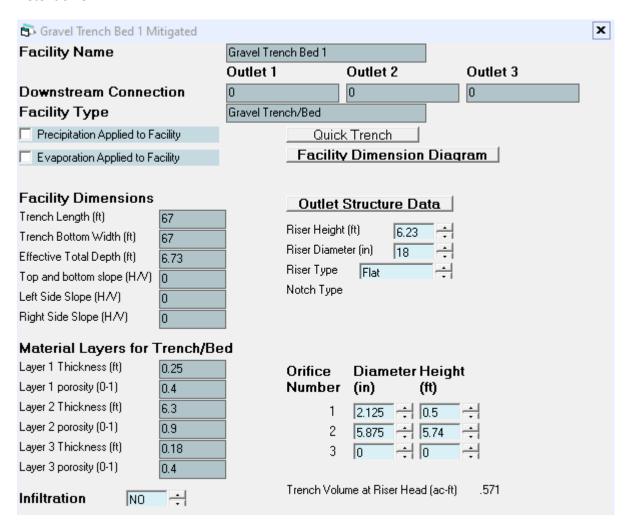
Detention 8

These calculations show that 5.73' of live storage is provided on top of 6" of dead storage and with 6" of freeboard. Freeboard is provided with the bottom 0.18' of the 12" top gravel section plus the top 0.32' of the tank section, totaling 6" of freeboard storage at the top of live storage. Dead storage is provided by the bottom 3" of the detention tanks as well as the 3" of gravel below the proposed tanks, totaling 6" of dead storage at the bottom of the detention system.

ACF Environmental HD R-Tanks shall be used for Detention 8. The manufacturer states that a porosity of 0.95 should be used for the R-Tank section; a porosity of 0.9 was used as a conservative design. A porosity of 0.4 was used for the top gravel layer.

Detention is proposed in the form of Detention 8, an ACF Environmental R-Tank detention facility. WWHM was used to size Detention 8. For WWHM flow control calculations showing the developed discharge durations meet the requirements of a Conservation Flow Control area, refer to Figure 4-1. ACF Environmental recommends that all R-Tank detention facilities have a maintenance row sized based on the water quality flow tributary to the detention facility. This maintenance row is not designed to provide any level of water quality treatment and is only provided to improve maintenance of the proposed facility; refer to Figure 4-2 for calculations showing the sizing of this maintenance row. For the exact location of Detention 8, refer to Figure 1-3.
